LITTLE YOUGHIOGHENY RIVER SITE NO. 2

NDI I.D. NO. MD 33

PHASE I INSPECTION REPORT

Little Youghiogheny River Site Number 2
(NDI ID. Number MD-33) Ohio River Basin
Cherry Glade Run, Garrett County, Maryland.

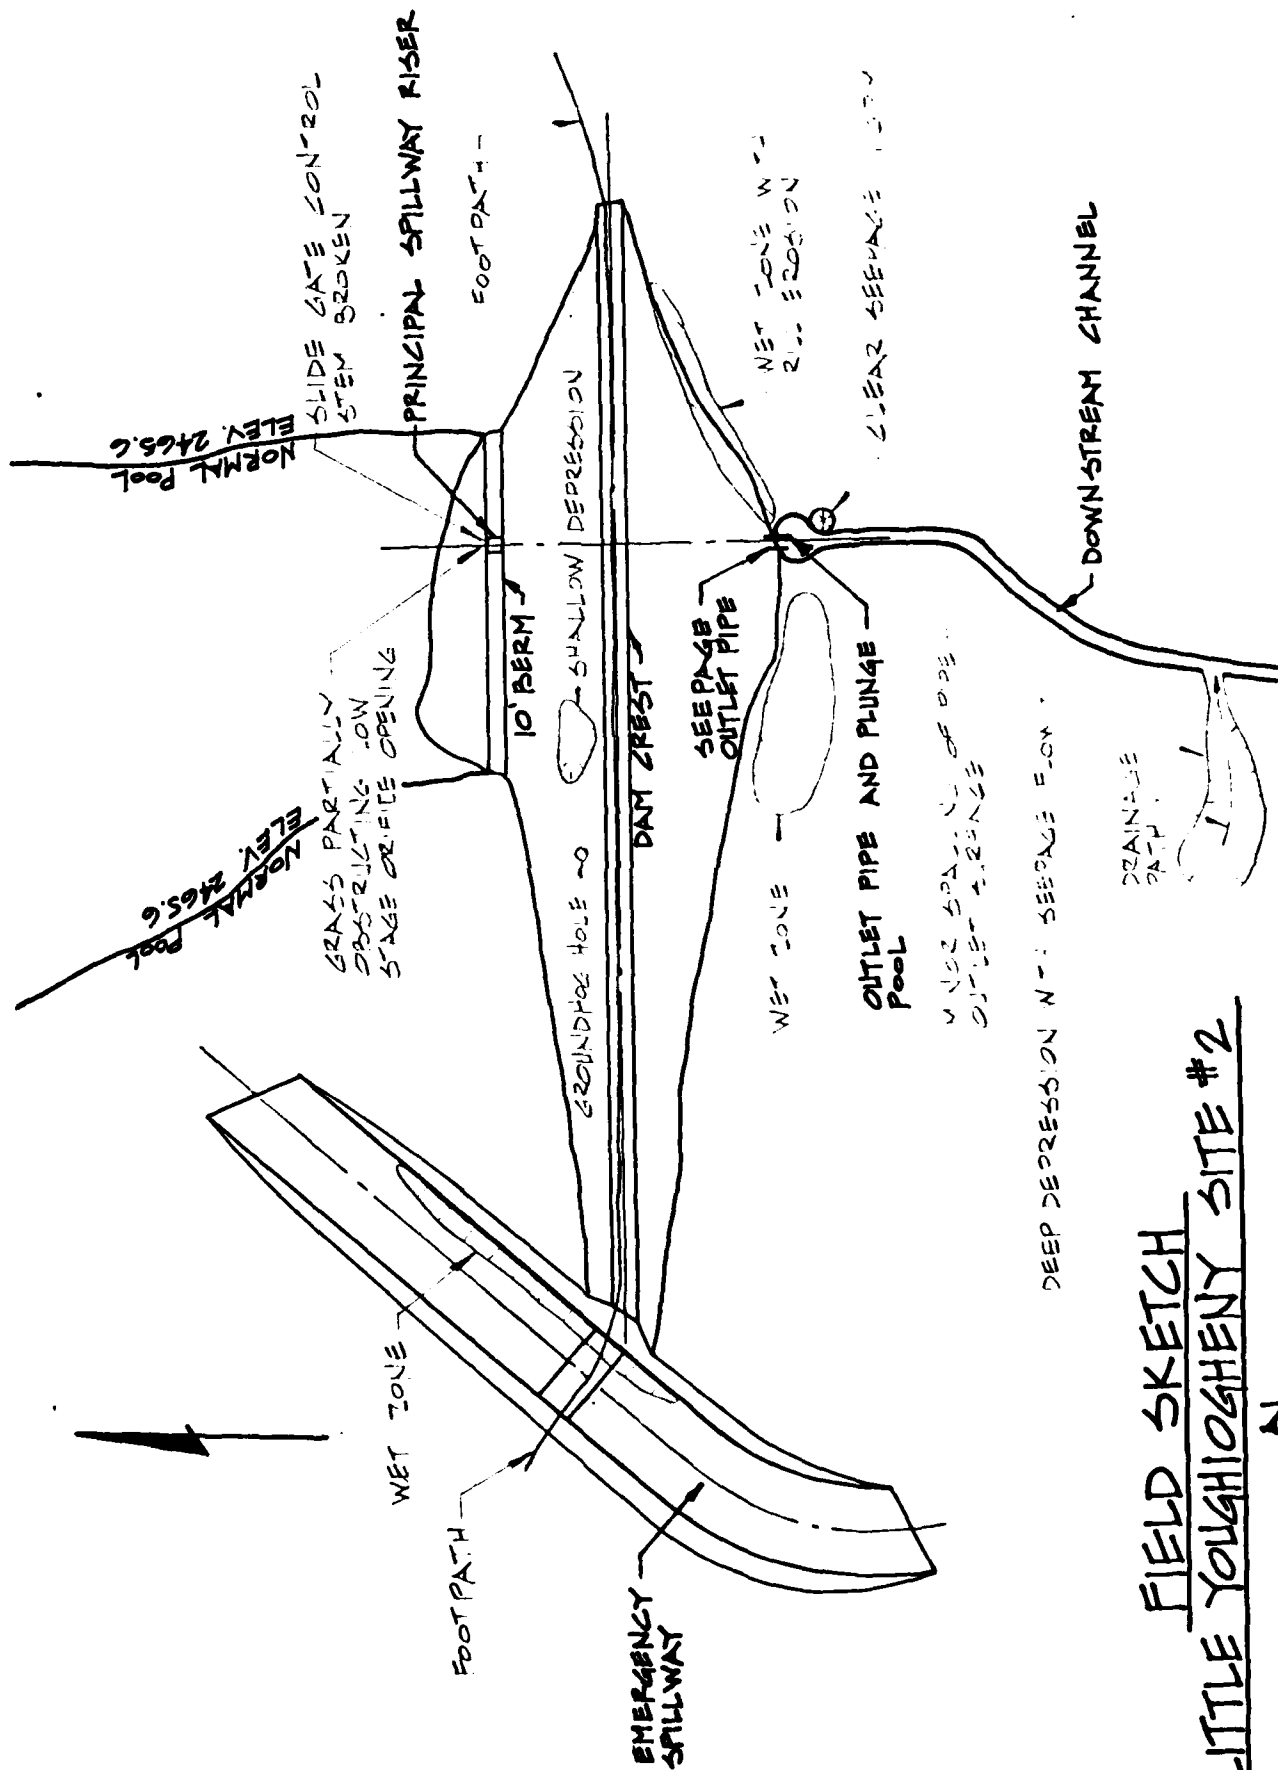
FIELD SKETCH
LITTLE YOUGHIOGHENY SITE #2
NI

| VISUAL EXAMINATION OF | OBSERVATIONS | REMARKS OR RECOMMENDATIONS |
|---|---|---|
| ANY NOTICEABLE SEEPAGE | Clear seepage emanating from left (east) bank of plunge pool (about 1 gpm). Wet zones were found located at the embankment toe (right (west) of the plunge pool) and about 300 ft. downstream of the dam. No measurable seepage is associated with the embankment toe wet zone. However, the downstream wet zone and depression is associated with spring flow (10 - 15 gpm). | |

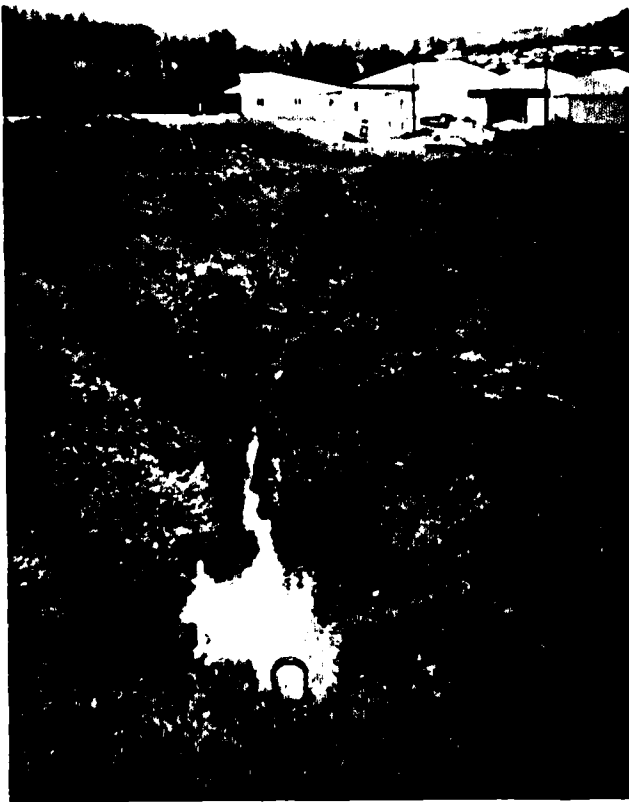
5

Plunge pool side slopes are steep, unlined, and show evidence of bank erosion. The plunge pool and exit channel were observed free of debris and flow obstructions.

| <u>VISUAL EXAMINATION OF</u> | <u>OBSERVATIONS</u> | <u>REMARKS OR RECOMMENDATIONS</u> |
|--|---|---|
| OUTLET CHANNEL | Plunge pool banks steep but stable. However, minor slope erosion was observed on plunge pool banks. Exit stream channel is cobble lined with stable side slopes. | |

Overview of plunge pool and downstream channel.

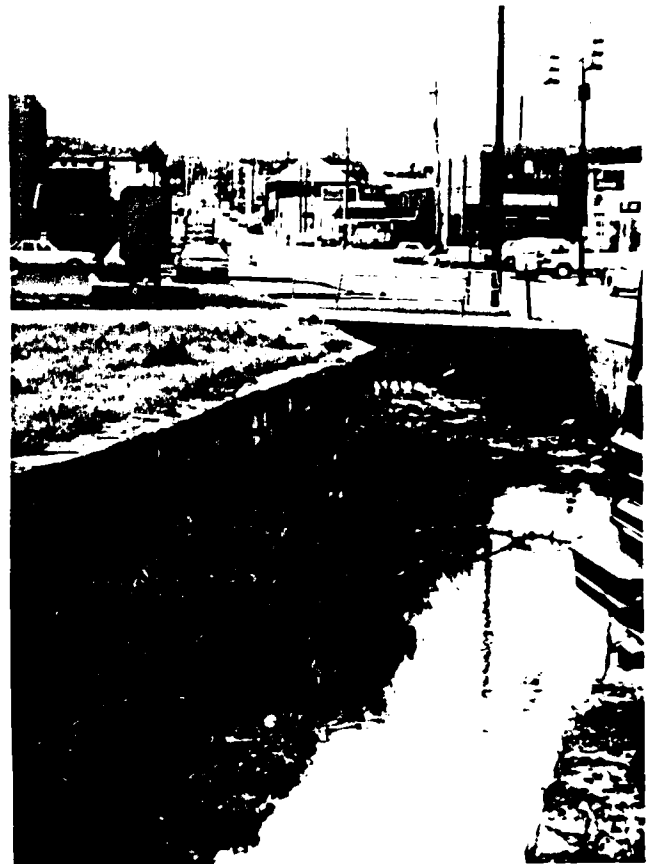
6

Wilson Run stream channel, downtown Oakland.
